# Manhole Inspection Summary

Manhole # S23E1\_008MH

**Location** Address: **2400 Harman Av**

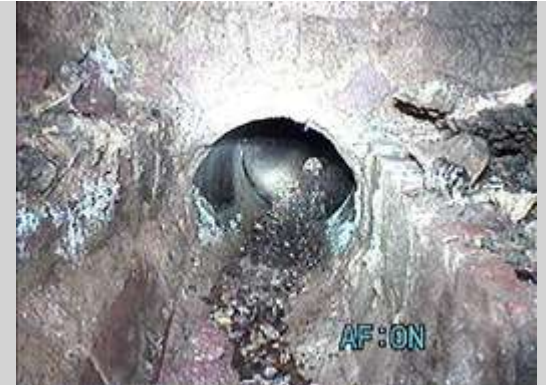
12 O'Clock Outflow

8 in. Circular Gravity Sewer  
Pipe Out @ 12 O'Clock

Pipe Height: **8.4** (in.) Rod and Bar (Angled)  
Pipe Material: **Clay** ☐ Pipe Lined  
Invert Depth: **12.53** (ft.) Flow Characteristics: **None**  
Deposits: ☒ None ☐ Mud ☐ Sludge ☐ **Debris** ☐ Grease  
Silt Depth: **0** (in.) Deposits Extent:  
Infiltration: **None** Pipe Seal Cond: **Sound**
